REDUCING TRANSPORT DAMAGE IN TOP-ICED SHIPMENTS OF FRESH VEGETABLES IN BUSHEL BASKETS

(A Study of Rail Shipments of Fresh Peas)

Marketing Research Report No. 772

By PHILIP L. BREAKIRON and C. J. NICHOLAS, *Transportation and Facilities Research Division*; JOSEPH K. STEWART, *Market Quality Research Division, Agricultural Research Service*; and R. S. KURTENACKER, *Forest Products Laboratory, Forest Service*

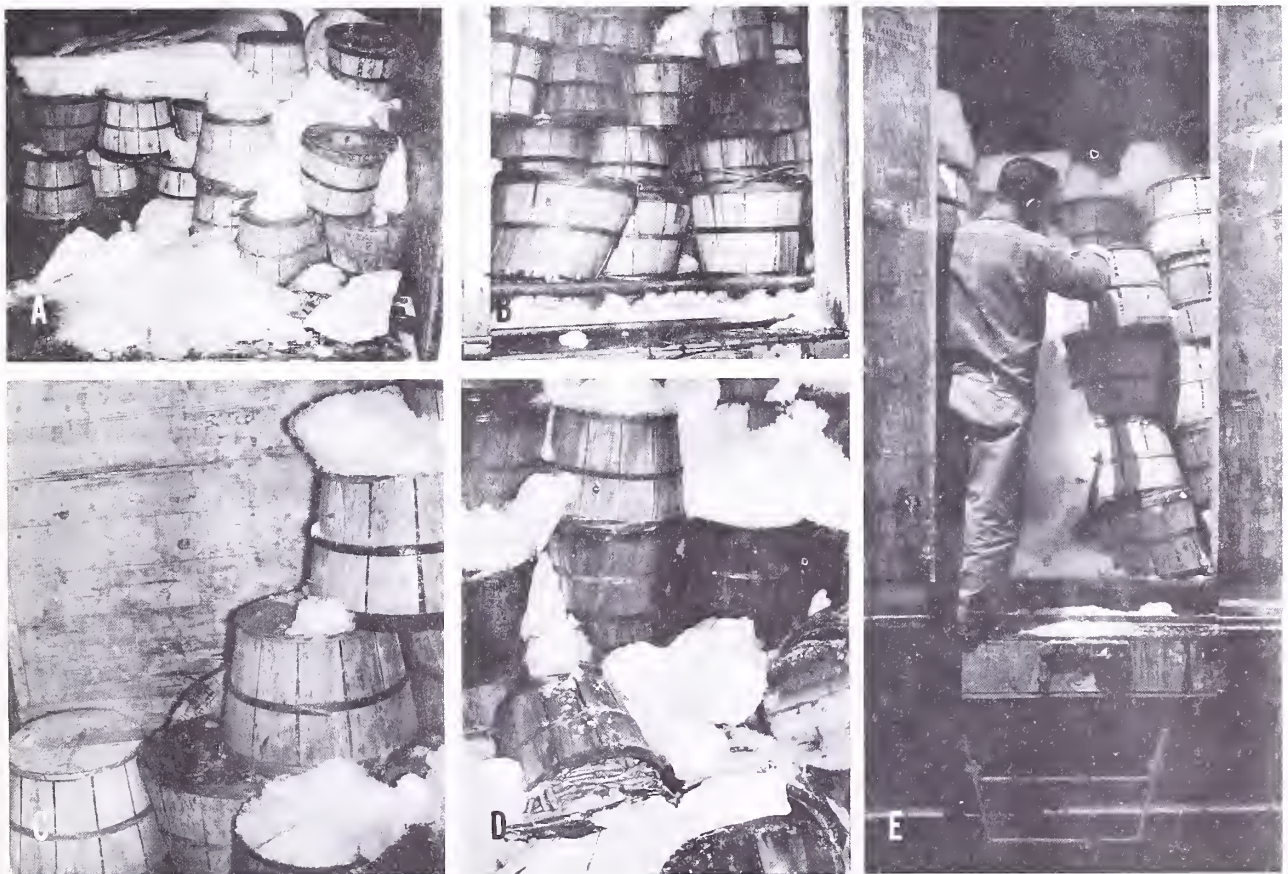
(A) BN-27912; (B) BN-27903; (C) BN-27908; (D) BN-27911; (E) BN-27910

FIGURE 1—Five of the most common types of transport damage encountered during shipment of fresh peas by rail refrigerator car. A, Badly squeezed baskets; B, cut staves and broken bottom hoop; C, broken middle hoops; D, spilled contents caused by loose cover; and E, badly wracked basket.

Of 4,253 baskets inspected, 1,037, or 24.4 percent, were damaged when they were unloaded at destination. The most prevalent type of damage was badly squeezed baskets (fig. 1A), which accounted for 34.1 percent of the damaged baskets. Baskets with broken hoops (fig. 1C) accounted for 25.1 percent of the damage; those with broken and loose covers (fig. 1D), 16.4 percent; badly wracked baskets (fig. 1E), 12.9 percent; baskets with broken and cut side staves (fig. 1B), 9.2 percent; and

baskets with broken and split bottoms, 2.3 percent.

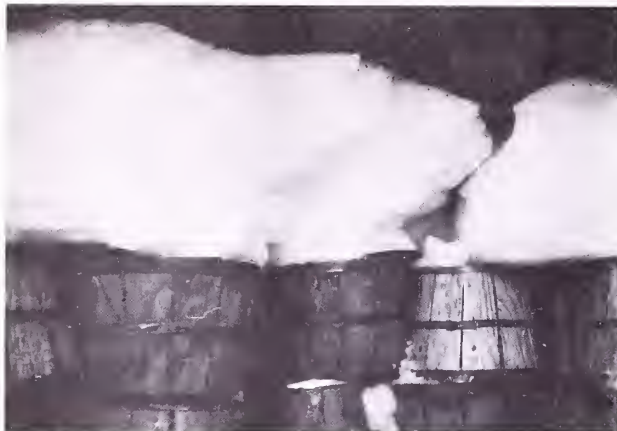
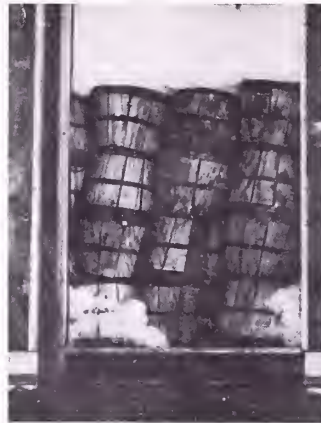
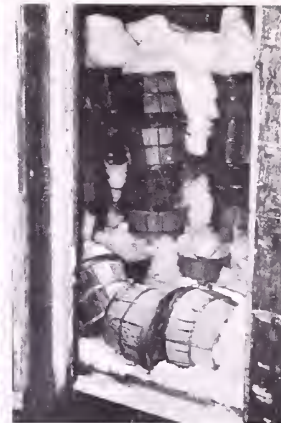
FIGURE 2.—Three of the most common causes of transport damage encountered during shipment of fresh peas by rail refrigerator car. (a) Heavy cover of top ice remaining at destination; (b) shifted vertical columns and lack of recess ice between baskets; and (c) vertical columns upset during switching of cars on team tracks.

Most of the damage was associated with shifting of loose, unstable loads from which most of the crushed ice in the spaces between the baskets had melted (fig. 2B). Observations showed the baskets were made of brittle shook material and the covers were too small to fit the tops of many baskets. Some baskets were poorly assembled. The weight of the large amount of top ice on some loads also contributed to damage, especially to baskets in the lower layers of the load (fig. 2A). Some damage also resulted from upsetting the vertical columns of baskets during switching of partly unloaded cars on team tracks (fig. 2C).

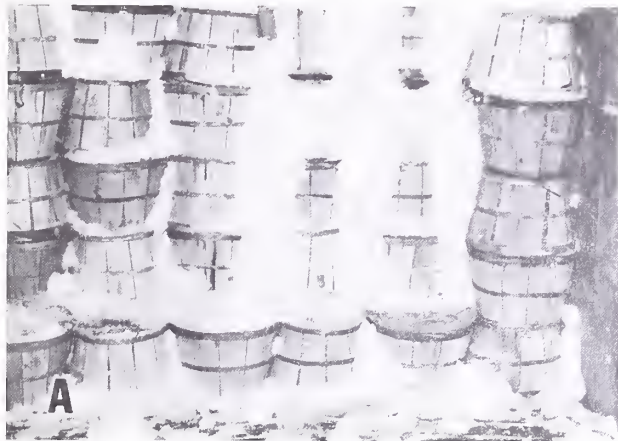
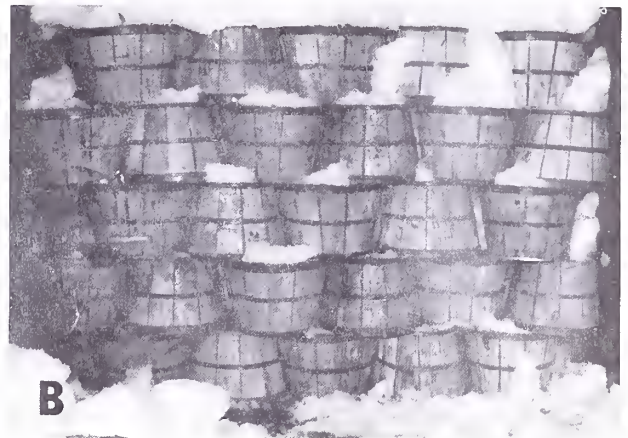
FIGURE 3.—Two methods of loading baskets of fresh peas inside refrigerator cars. *A*, Conventional, nonoffset, bottom-to-bottom and top-to-top, alternately inverted loading pattern; and *B*, crosswise-offset, alternately inverted pattern.

Load Patterns.—Shipping tests were conducted during the 1961 and 1962 shipping seasons to compare basket damage and ease of loading and unloading of the conventional pattern and a pattern previous research had shown to give a tight, stable load for peaches shipped in bushel baskets but without top ice.² In the conventional pattern, baskets were stacked alternately bottom-to-bottom and top-to-top (fig. 3A). The bottom-to-bottom and top-to-top stacking also was used in the experimental pattern, but the baskets were offset crosswise (fig. 3B). Transport researchers gathered data by inspecting 10,377 baskets in 11 shipments with the new loading pattern and 15 control shipments using the conventional one.

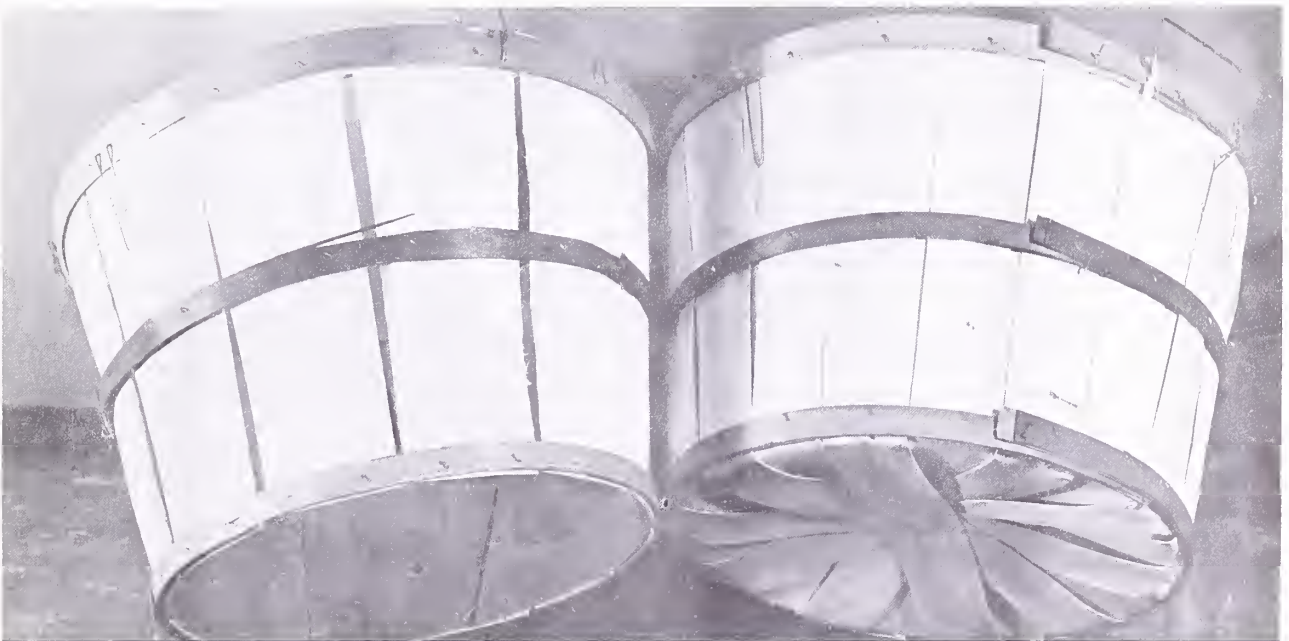
N-58472

FIGURE 4.—Solid bottom basket (left) and continuous-stave basket (right).

Basket Design.—Performances of conventional solid-bottom and continuous-stave baskets made primarily of gum wood (fig. 4) were compared in two controlled shipping tests using the conventional and offset loading patterns. An equal number of each type of basket

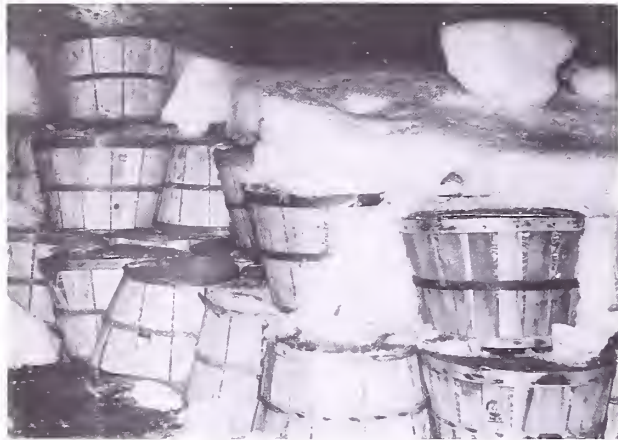
BN-27904

FIGURE 5.—Partly unloaded, longitudinally split load of solid bottom baskets (left background) and continuous-stave baskets (right foreground).

was packed in the same fields and loaded into the same refrigerator car, with the continuous-stave baskets on one side of the car and the solid-bottom baskets on the other side (fig. 5). The baskets were inspected at destination and the type and amount of damage were recorded for each basket. Refrigeration data were not

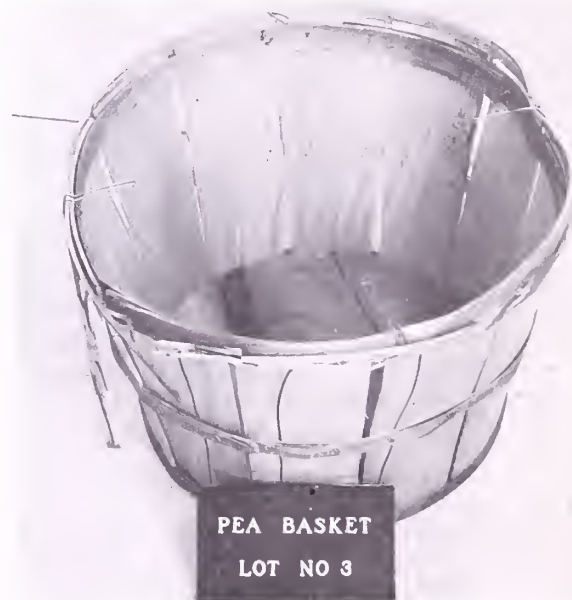
FIGURE 6.—Basket subjected to hoop removal test, showing typical failure of outside top hoop because of splitting at the staples.

The types of basket failure for many of the lots in the tests were similar and did not appear to be altered by slight modifications in basket design. In the top-to-top and bottom-to-bottom compression tests, the type of failure and condition of all baskets at maximum load were the same for all lots except lots 3 and 5. The most usual types of failure were buckling and breaking of the staves across the grain of the wood, and occasionally, some staples pulling at the center hoop. In lots 3 and 5 the staves buckled inward or outward, but usually did not break across the grain. Therefore, when the load was removed, the baskets regained their original shape. All lots tested showed the same type of failure in the side-to-side compression tests. This was buckling, breaking, or splitting of the cover slats. In the hoop removal tests of lots 3 and 5, the top hoops split and some staples pulled through the top hoops (fig. 6). In all

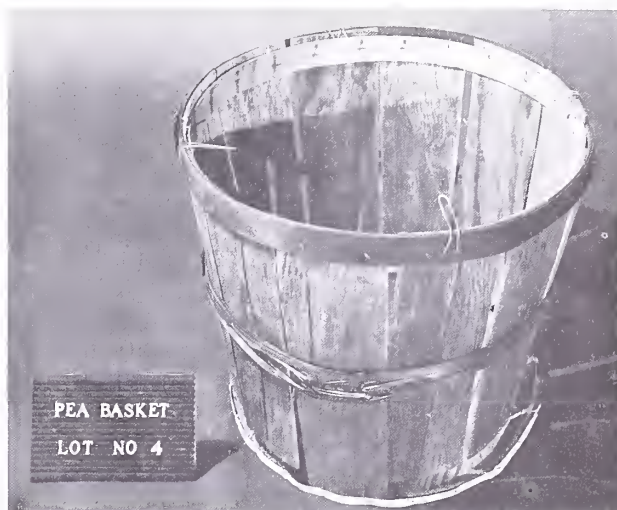
BN-27907

FIGURE 7.—Basket with $\frac{3}{8}$ - by 0.010-inch metal bottom hoop showing typical failure of staves shearing from bottom staples in hoop removal evaluation.

other lots, the bottoms were pushed out because the staves were sheared from the staples at the bottom (fig. 7).

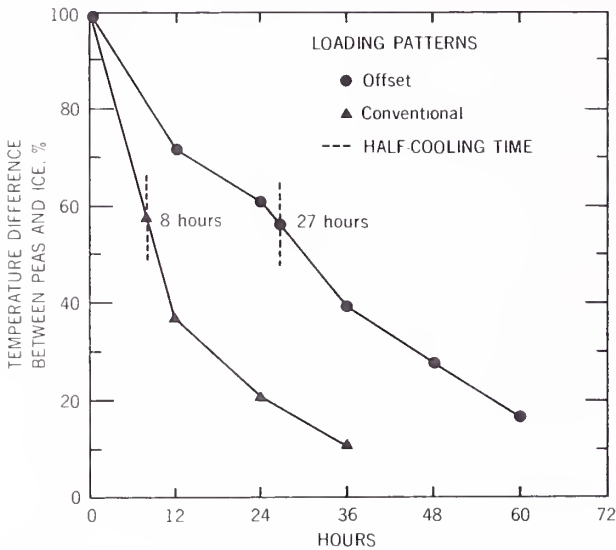
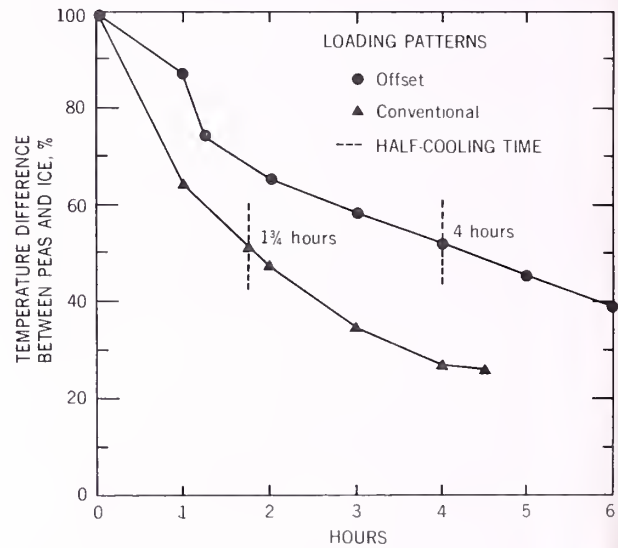
FIGURE 8.—Cooling rates of top-iced fresh peas packed in bushel baskets and positioned in rail cars in two different loading patterns. Cooling rates (left) before transit, test No. 6, and (right) during transit, test No. 7.

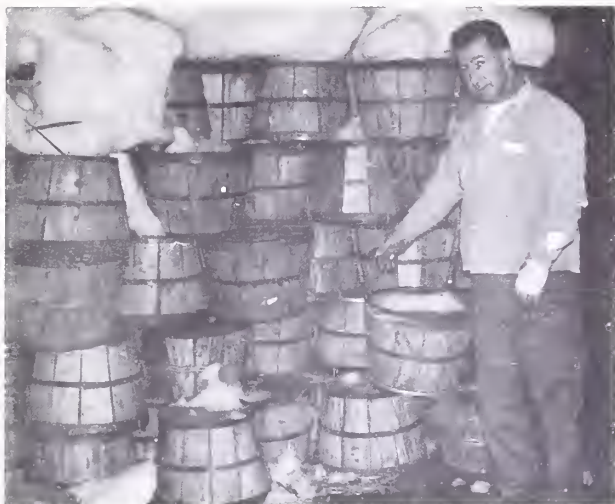
BN-27915

FIGURE 9.—Cross section of a partly unloaded, cross-wise offset load of fresh peas showing lack of recess ice in body of load.

crosswise-offset pattern. Offsetting the baskets crosswise of the car prevents the crushed ice from shifting down into the spaces between the baskets in the lower layers (fig. 9). The smaller amount of ice that sifted down into the spaces of the body of the offset loads was demonstrated by the differences in the depth of top ice at shipping point. The four offset loads, for example, had an average of 17 inches and the four companion, conventional loads had 12 inches, even though nearly equal amounts of ice were applied to all eight cars.

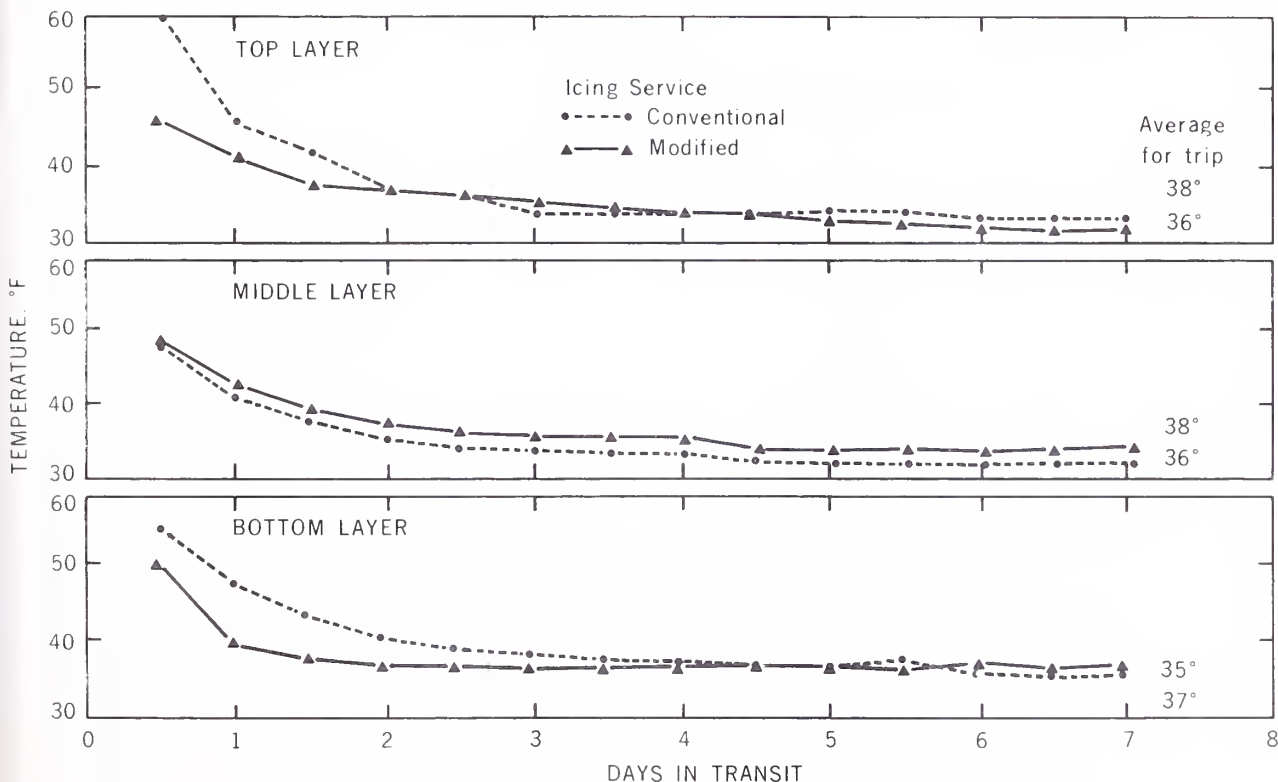
FIGURE 10.—Transit temperatures of fresh peas in bushel baskets in rail cars during transit, as influenced by type of icing service, test No. 8.

In one paired shipment, initial cooling of peas in loads with conventional icing and with modified icing was the same (half-cooling time was 15 hours), and transit temperatures were about the same (fig. 10). In another shipment, half-cooling time of peas was 14 hours in the load with conventional icing and 25 hours in the load with modified icing. After the fourth day, temperatures in the middle of both loads were about the same (fig. 11). Temperature records for the other two pairs of cars were incomplete because of failure of several of the recording thermometers. However, average trip temperatures, determined from the thermometers which did not fail, differed for loads with conventional icing and with modified icing by only one or two degrees for both pairs of cars (table 10, appendix).

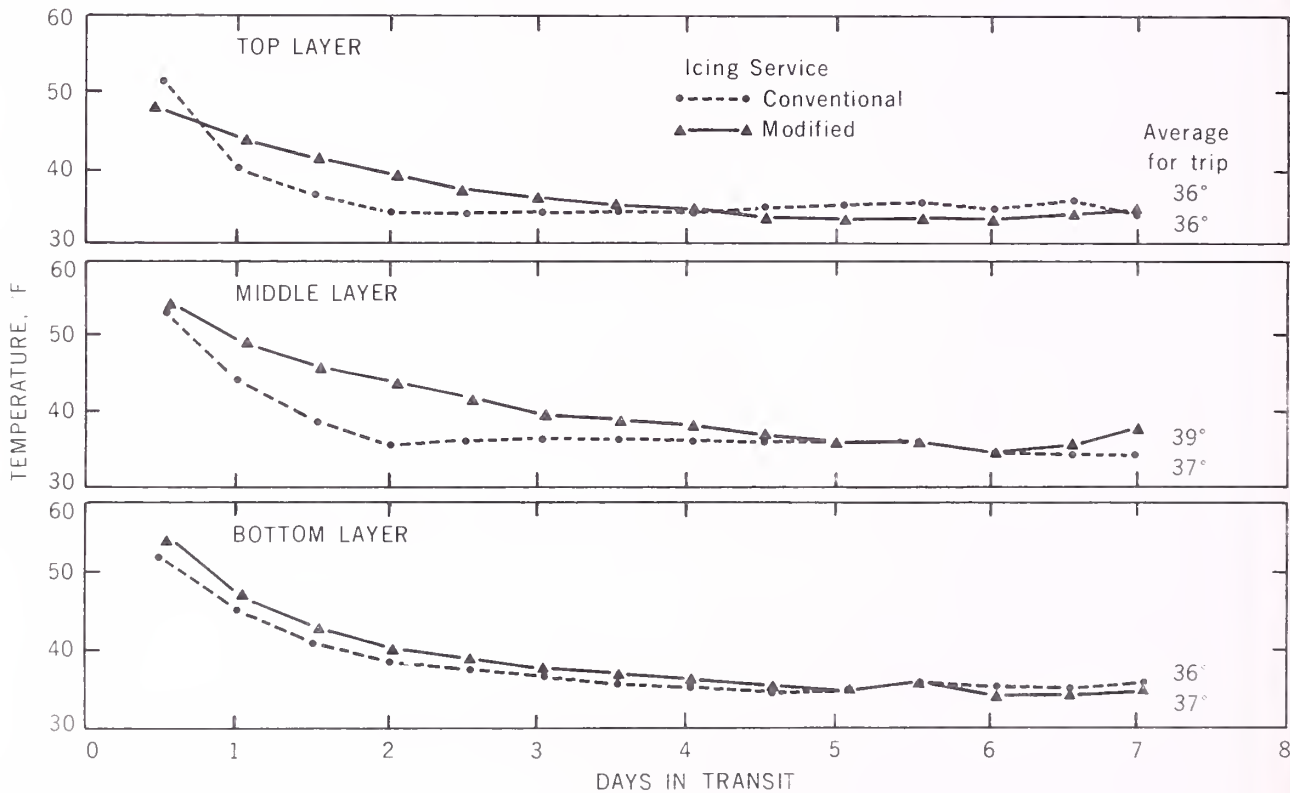
FIGURE 11.—Transit temperatures of fresh peas in bushel baskets in rail cars during transit, as influenced by type of icing service, test No. 9.

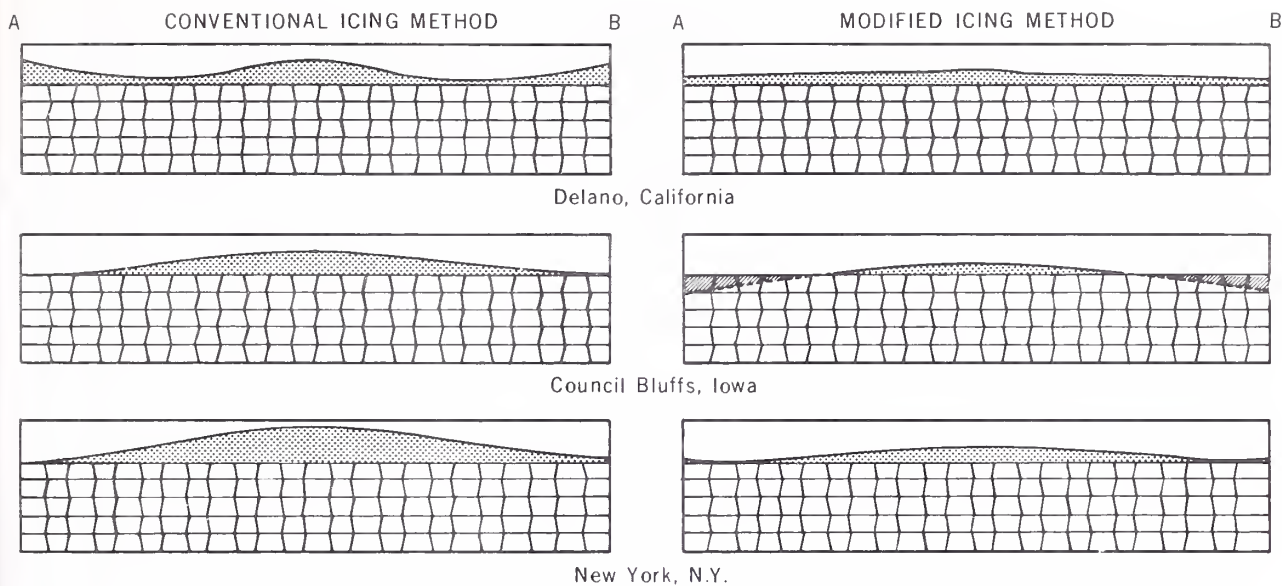
FIGURE 12.—Top-ice distribution profiles for paired loads of bushel baskets of fresh peas in rail cars with conventional and modified icing, showing average amounts of ice on loads at shipping point (Delano), re-icing station (Council Bluffs) before re-icing, and destination (New York). (A and B indicate the ends of the cars; B is the brake end.)

Figure 12 shows that the greatest meltage occurred in the ends of the cars and the least in the middle of the loads. In the cars with modified icing the circulating air discharged onto the load from the fans to the top of the bunker bulkheads was cooled from its passage through the bunker ice. The smaller amount of top ice placed on the loads at the shipping point did not block the circulating air as much as the larger amounts of ice on the conventionally iced loads. When the crushed ice was applied at the re-icing point, the light cover of ice remaining on the loads permitted much of the crushed ice to sift down into the spaces between the columns of baskets. The ice in the load recesses increased the number of baskets in direct contact with the ice and helped to stabilize the loads during the remainder of the transit period.
